**TECHNICAL REPORT  
NATICK/TR-95/026**

# **VENTILATION SYSTEM FOR THE MOBILE KITCHEN TRAILER**

**FINAL REPORT  
November 1991 - September 1994**

**U.S. ARMY SOLDIER SYSTEMS COMMAND  
NATICK RESEARCH, DEVELOPMENT AND ENGINEERING CENTER  
NATICK, MASSACHUSETTS 01760-5018**

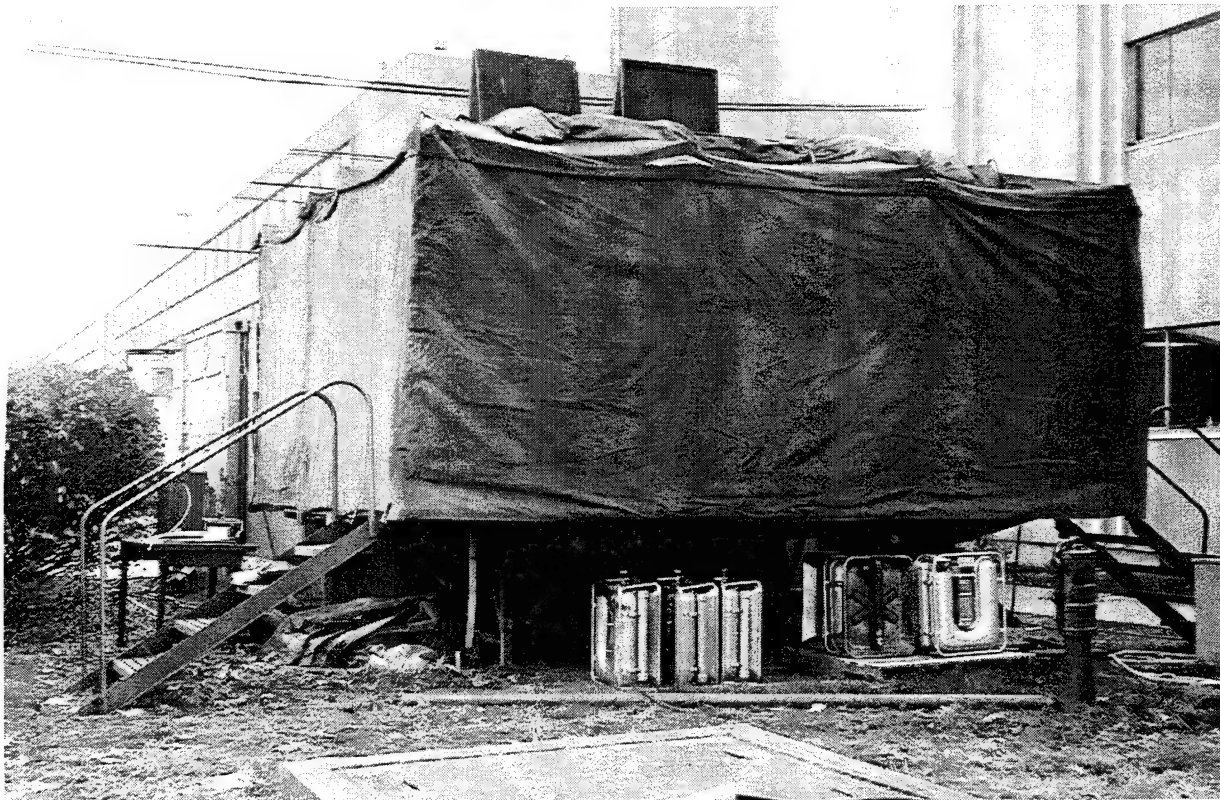
The Mobile Kitchen Trailer (MKT) shown in Figure 1 is an expandable, self-contained, trailer-mounted, field food service system designed to provide food service for approximately 250 personnel per meal. This system consists of standard field cooking equipment packaged in a configuration to allow efficient preparation of type A and B rations. Arrangement of the equipment includes preparation counters, cooking areas and a serving line. The MKT roof is manually raised and the sides are either fabric or screen for environmental protection. A picture of the screen sides in place on the MKT is shown in Figure 2. The kitchen is mounted on a standard 1-1/2-ton M-103A3 trailer chassis. The M-103A3 trailer is designed to be towed by a standard 5-ton tactical vehicle over cross-country, highway terrain, and air-transported under a CH47 helicopter or internally by Air Force cargo aircraft.<sup>6</sup>

Figure 1. Mobile Kitchen Trailer (MKT) with canvas sides.

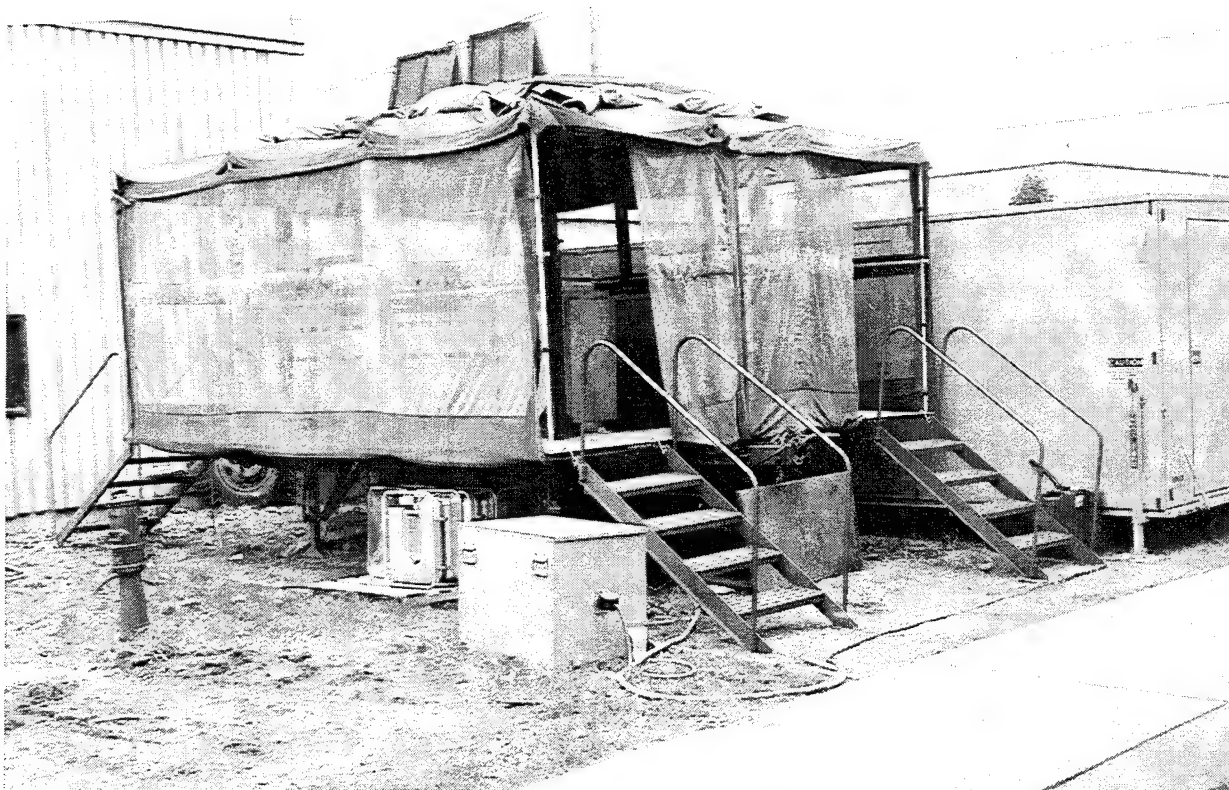
Figure 2. Mobile Kitchen Trailer (MKT) with screen sides.

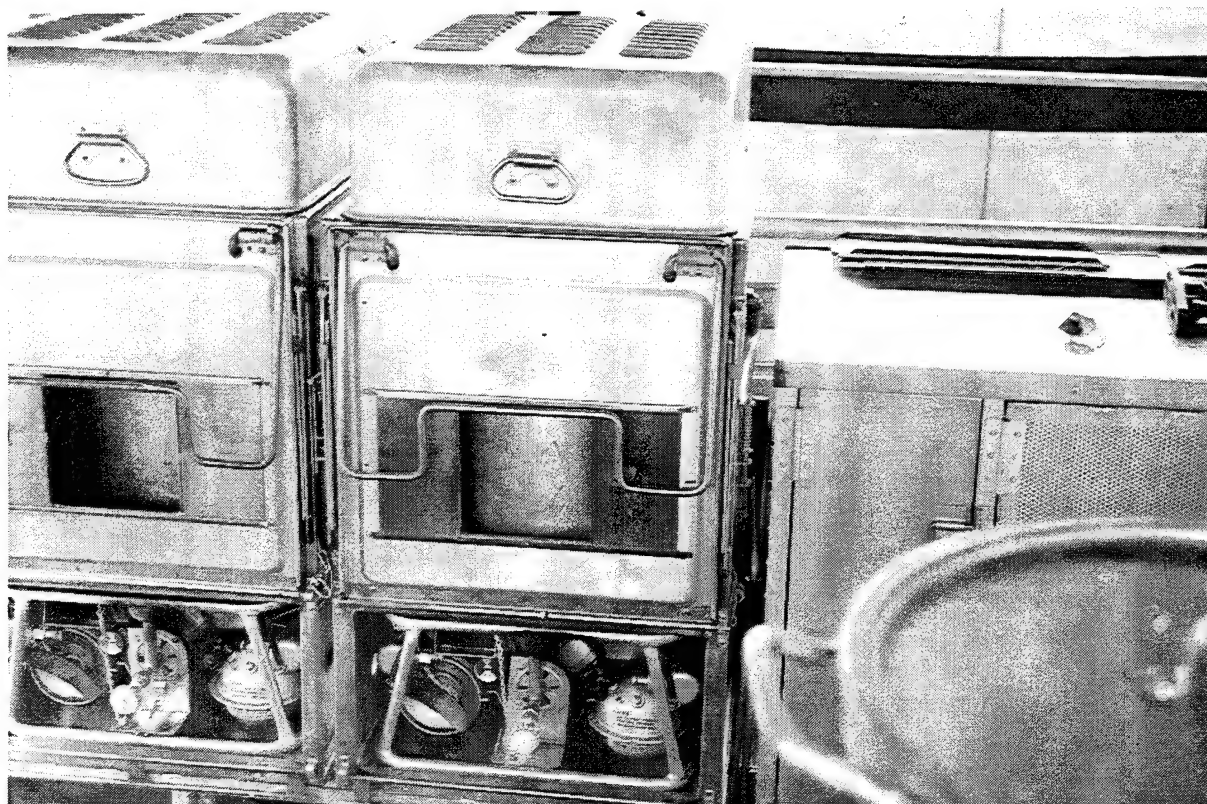
functions as an oven, it has two positions at the base of the cabinet that the M-2 burner can be placed to vary the intensity of the heat. The top of the M-59 range cabinet can be opened for placing a square-head (deep rectangular pans that include a cover) or a full sized pan for cooking stews or cakes etc. The front of the M-59 range cabinet opens like a conventional oven and has two sliding panels on the front for viewing or cooling the M-59 range cabinet. Square-heads, full sized pans, or a ten or 15-gallon stock pot can be slid into the cabinet from the front. A picture of two M-59 range cabinets is shown in Figure 3.

Figure 3. M-59 Range Cabinets used in the MKT.

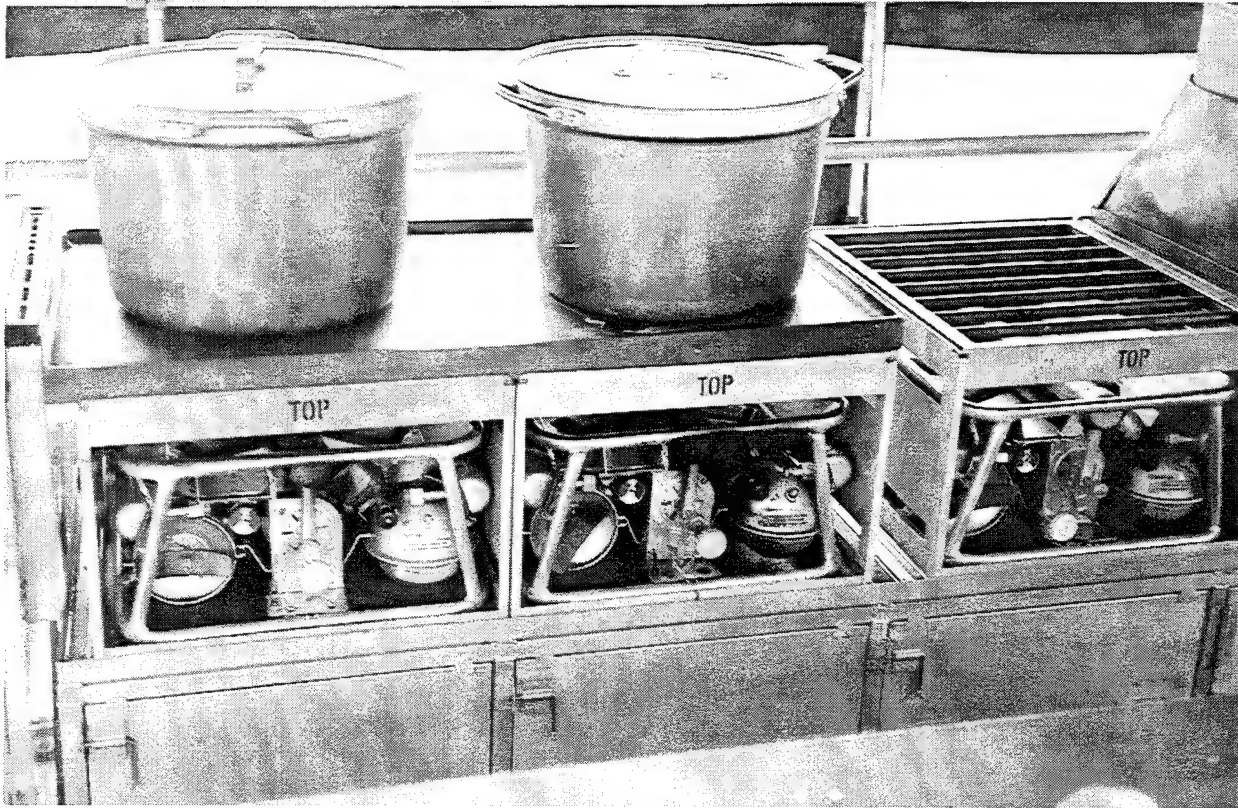
The MKT's griddle is large enough for two M-2 burners to fit beneath it. The griddle has a raised edge around the perimeter to contain grease and hold stainless steel sides that prevent grease from splattering on personnel as they walk by in the service line. On the right end of the griddle a hole is cut for a grease chute.

Figure 4. Griddle and Grill used in the MKT

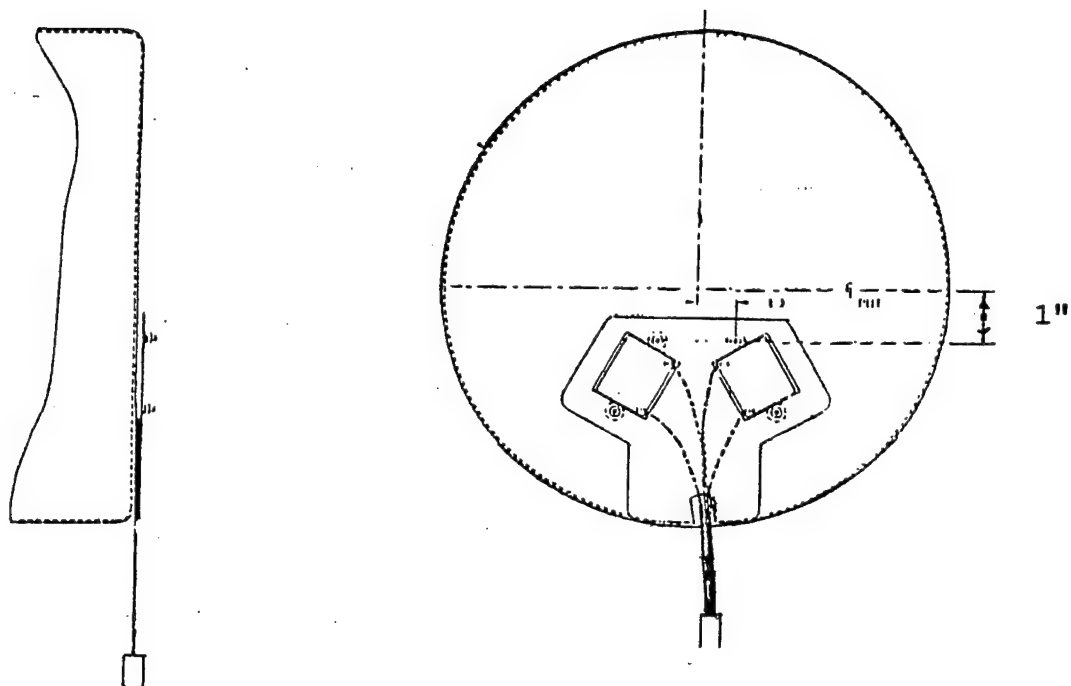
Figure 5. Placement of thermoelectric converters on the bottom of a 15-gallon stock pot.

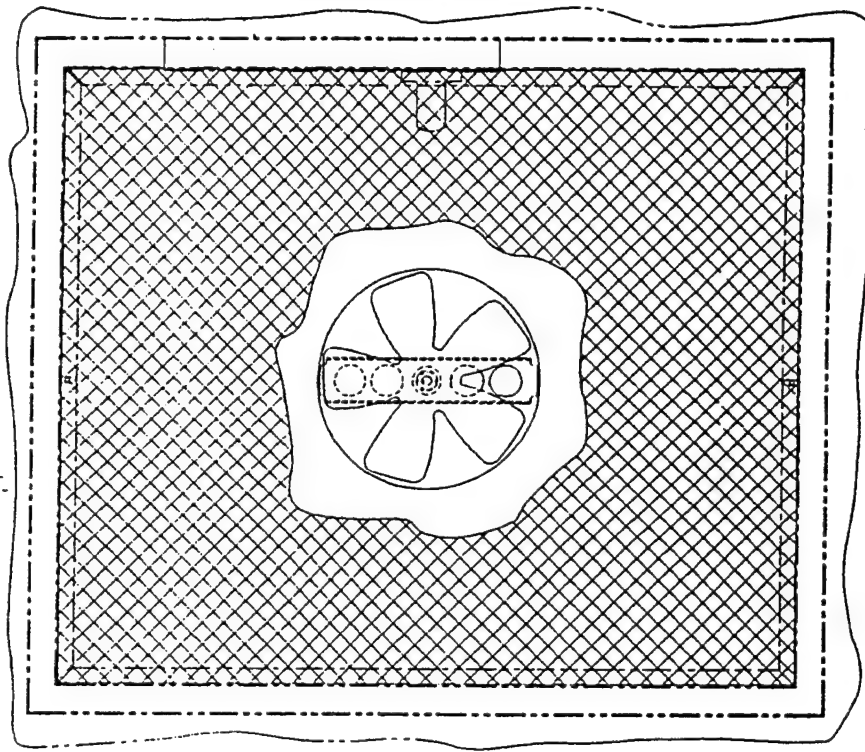
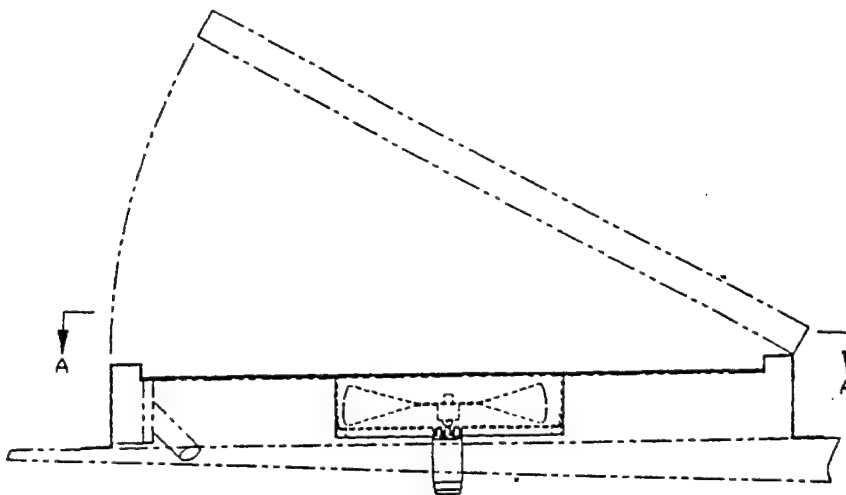
Figure 6. Placement of thermoelectric-powered fan assembly in the Mobile Kitchen Trailer's roof vent.

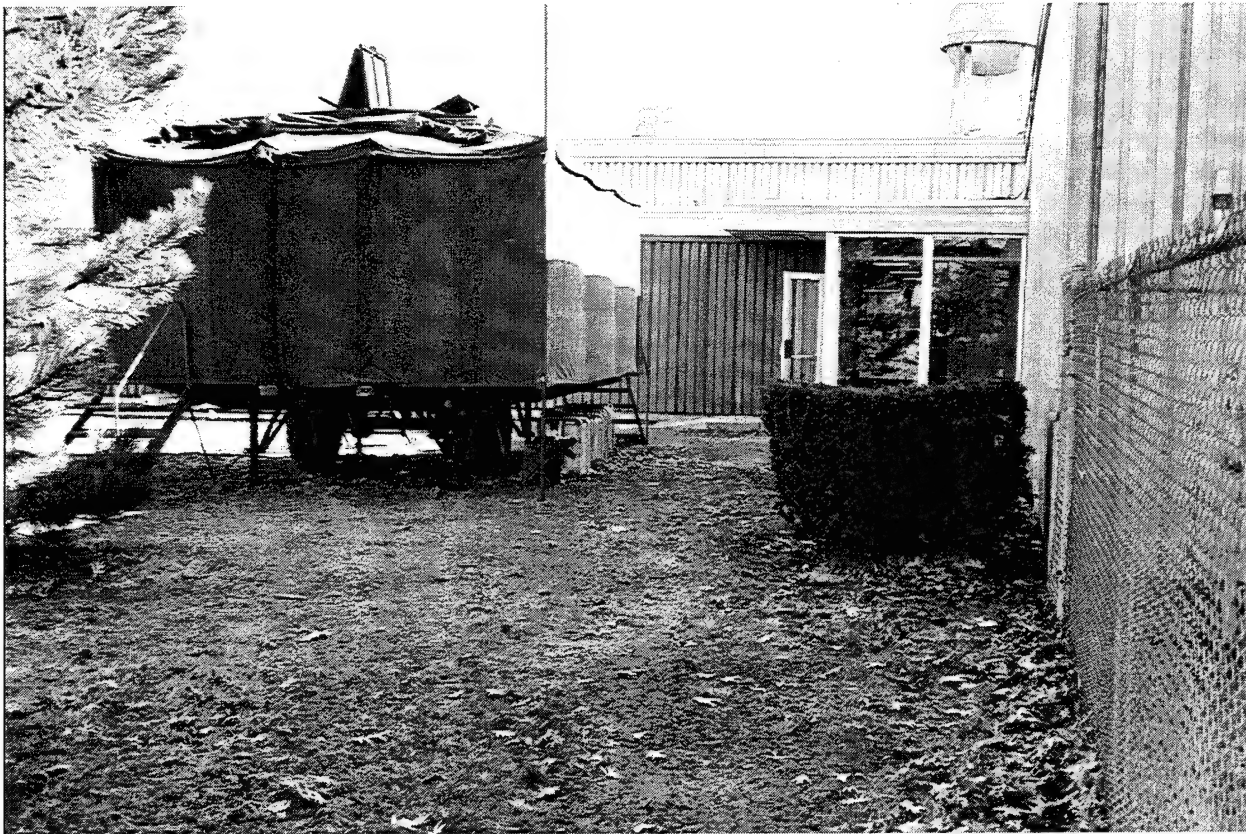
Figure 7. MKT's location for testing.

In establishing a baseline, the number of variables affecting the concentration of the combustion products had to be kept to a minimum. The configuration chosen to accomplish this was to close-up the MKT and shelter it from the wind. The MKT was positioned in the corner of two buildings that sheltered the MKT from the wind in two directions, see Figure 7. For testing the combustion products, three M-2 burners (one for the M-59 range cabinet, grill and griddle) were operated at high, medium and low capacity. To simulate cooking, fifteen-gallon stock pots were filled with water and placed above each burner. The stock pots acted as heat sinks for the heat produced by the burners.

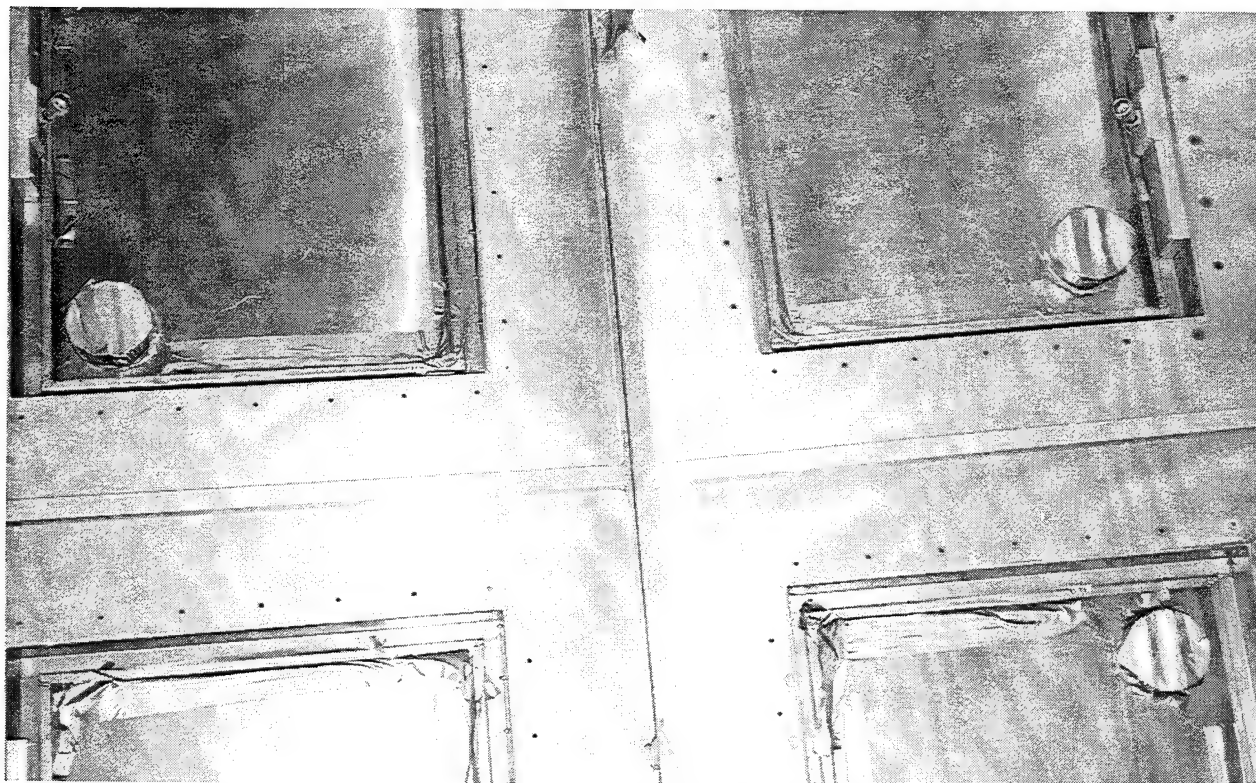
Figure 9. New roof vent covers viewed from inside of the MKT.

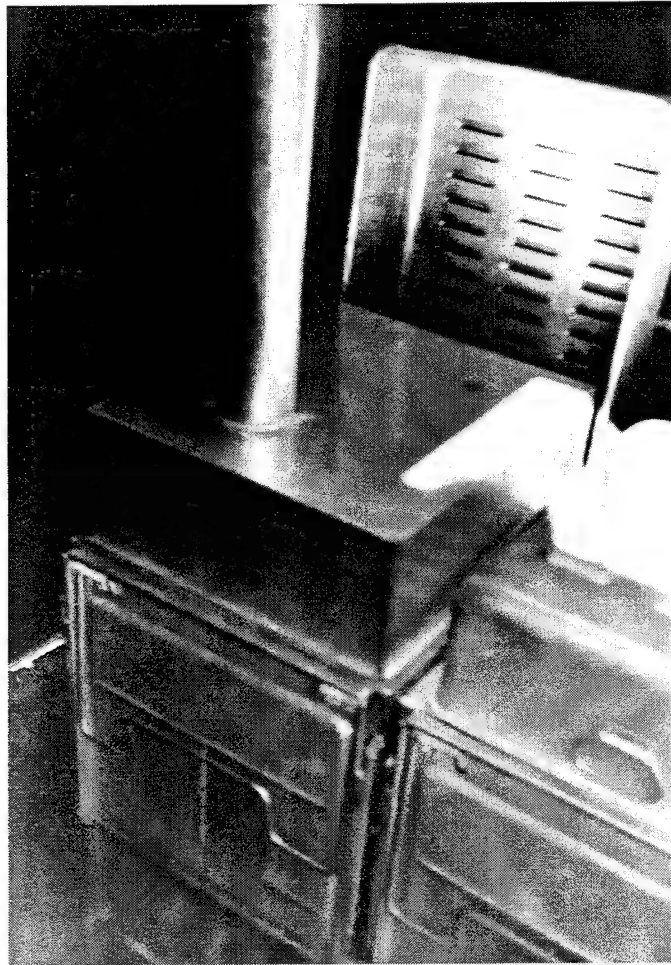
Figure 10. M-59 range cabinet with equipment vent installed.

The M-59 range cabinet, griddle and grill on the outside ends of the center aisle were the positions chosen for the M-2 burners and the equipment vents for testing. The equipment vents were installed by positioning them (cover for the M-59 range cabinet, the cowl and the griddle riser) below the sleeves in the new roof vents. Stove pipe cut to the proper length was slid over the sleeve in new roof vents and then over the sleeve of each equipment vent. Pictures of the configuration of the M-59 range cabinet and cowl are shown in Figures 10 and 11, respectively.

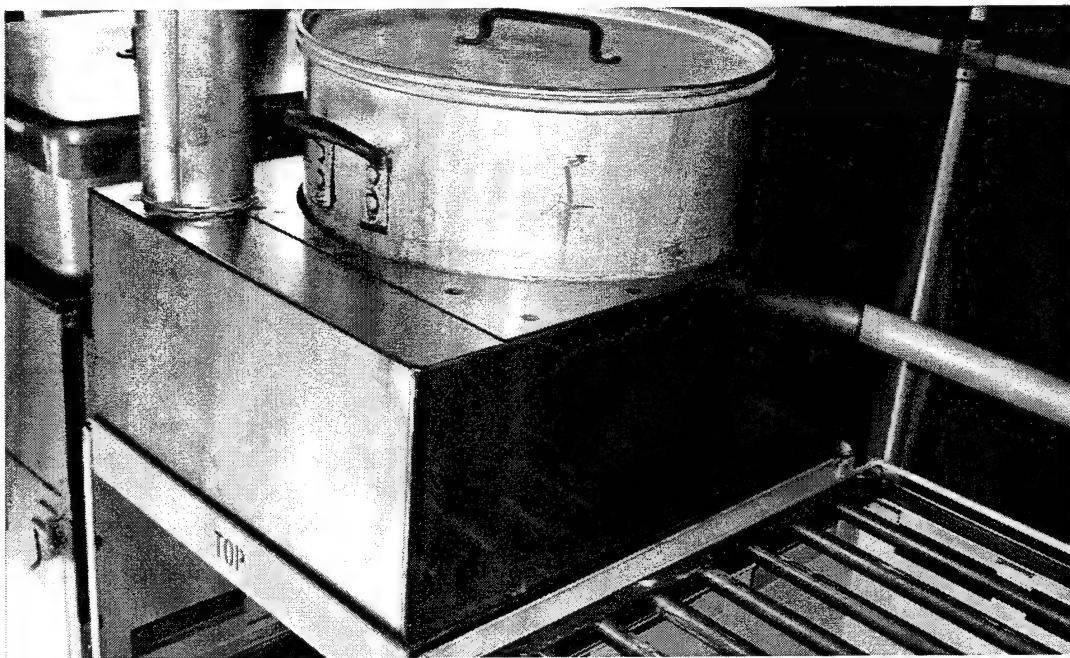
Figure 11. Grill with cowl used for the equipment vents.

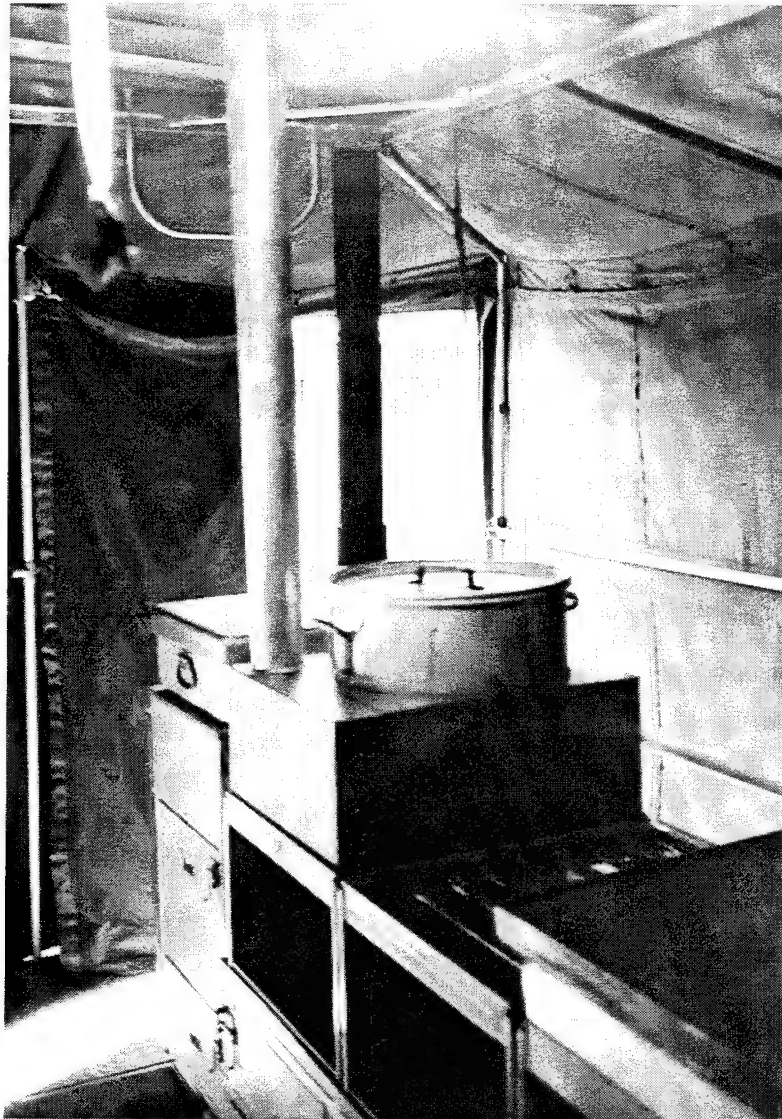
A picture of the cowl and stack connecting to a new roof vent is shown in Figure 12.

Figure 12. Cowl and stack used for equipment vents.

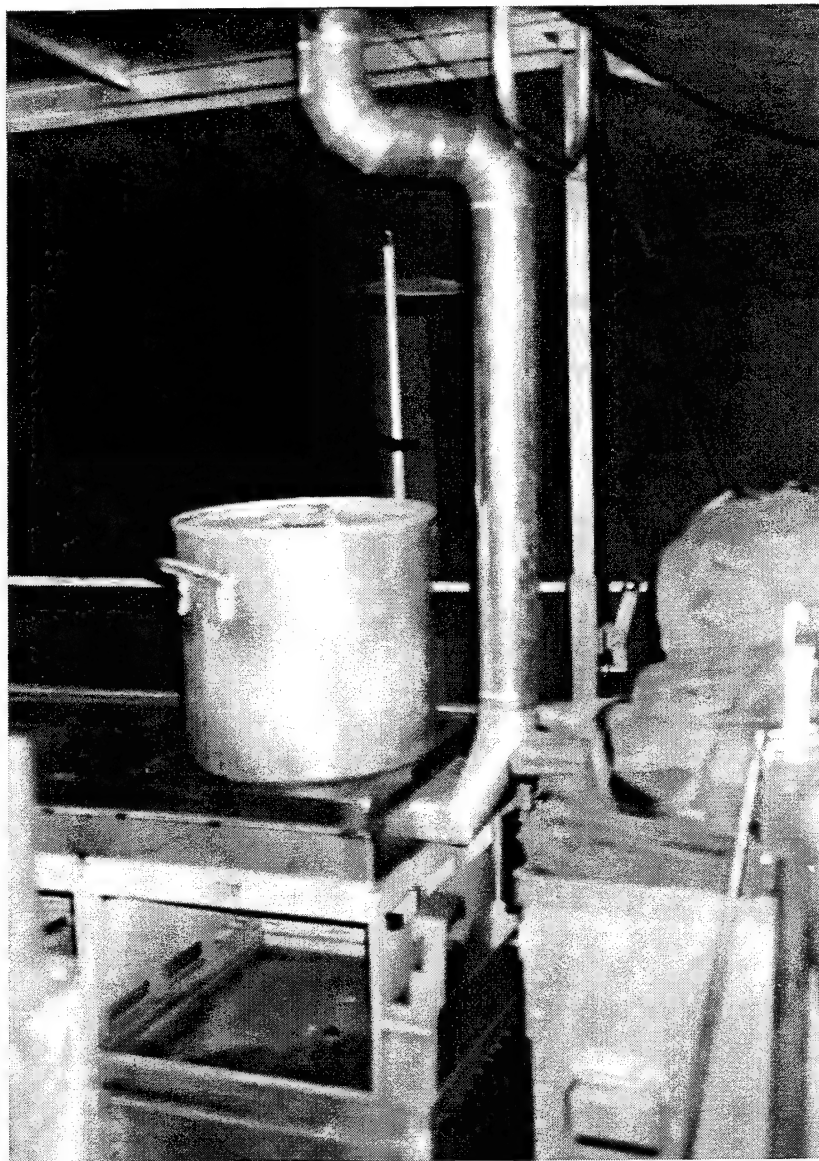
For the griddle, two 90° bends were added to position the stove pipe from the griddle below the new roof vent. A picture of the griddle riser and stack connecting to the new roof vent is shown in Figure 13.

Figure 13. Griddle and stack used for the equipment vent.

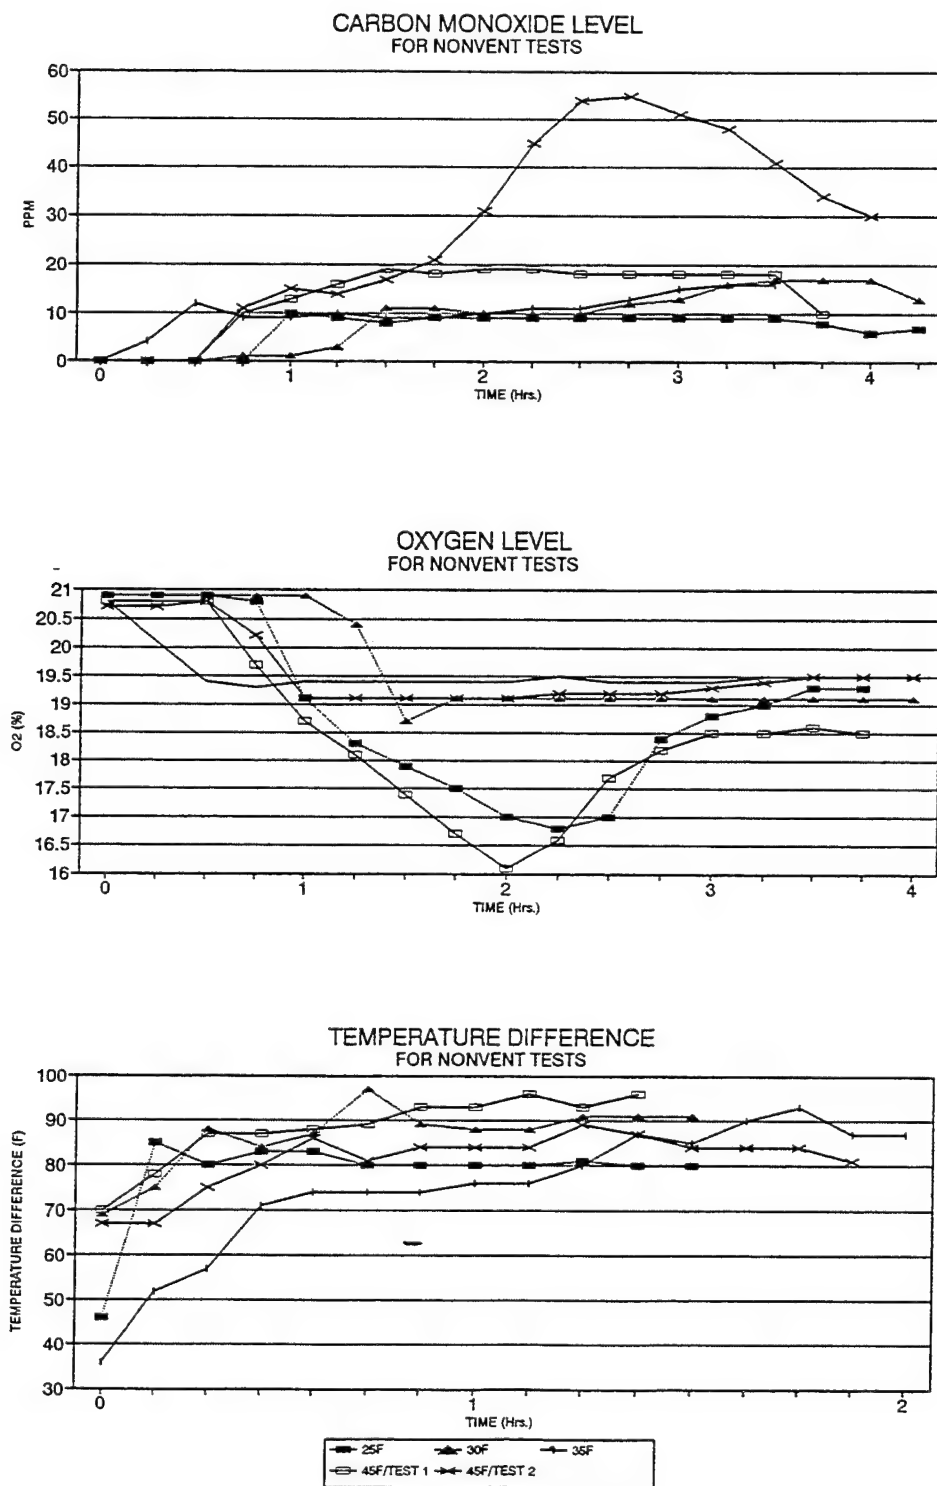
The oxygen level graph shows the effect the ambient temperature has on the percentage of oxygen within the MKT. All of the ambient temperature test results eventually stabilized at approximately 19.0%, except for 45°F/Test 1. However, initially the 25°F and the 45°F/Test 1 ambient temperatures result dropped significantly before stabilizing at approximately 19.0%. The drop of the percentage of oxygen at the 25°F and 45°F/Test 1 ambient temperatures in the beginning of the tests, were likely a result of a delay in the heated air drafting out of the MKT. This phenomena is similar to starting a fireplace, where the chimney needs to be heated before the combustion products begin to draft up and out of the chimney, with the MKT functioning as a chimney.

Figure 14. Gas concentrations and temperature difference within the Mobile Kitchen Trailer when using three M-2 burners at various ambient temperatures.

The temperature difference shows the effect the ambient temperature has on the temperature difference between the 1 ft. and 5 ft. distances from the floor in the center of the MKT. All of the ambient temperature test results in this figure eventually stabilized at approximately 85°F, except for test 1 at the 45°F ambient temperature. These results confirm the extreme temperature gradient from floor to ceiling experienced by the personnel working within the MKT.

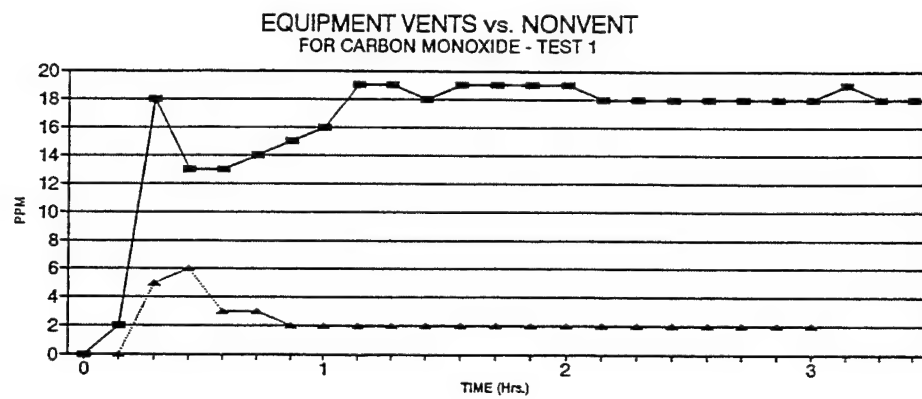
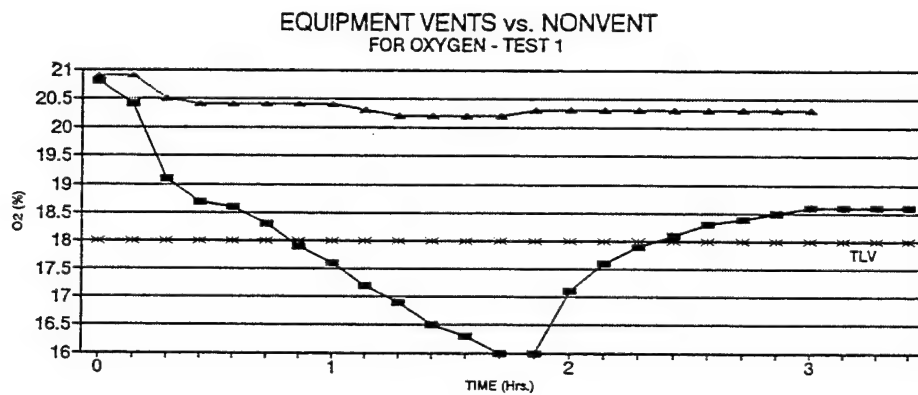
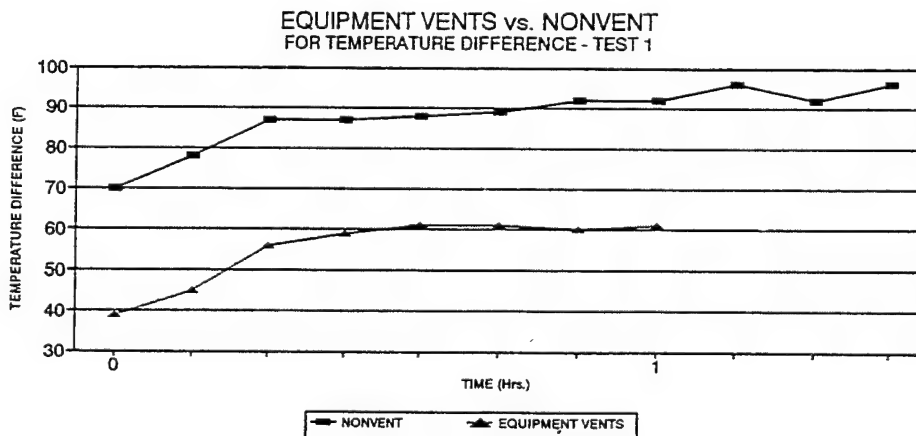
The temperature difference in Figures 15 and 16 shows the reduction of the temperature difference between the 1 ft. and 5 ft. distance from the floor within the MKT with the equipment vents installed. In the nonvent configuration, the average

Figure 15. Gas concentrations and temperature difference within the Mobile Kitchen Trailer when using three M-2 burners at an ambient temperature of 45°F (test 1).

temperature difference stabilized at approximately 88°F. In the vented configuration, the average temperature difference stabilized at approximately 55°F. The results from the vented and nonvented configuration are similar for both tests 1 and 2. The Figures show that the temperature difference was reduced by approximately 32°F with the equipment vents installed. (Note: The results for the nonvented configuration begin at a higher initial temperature, because the MKT was tested with the equipment vents first and not given adequate time to cool before initiating testing of the nonvented configuration.)

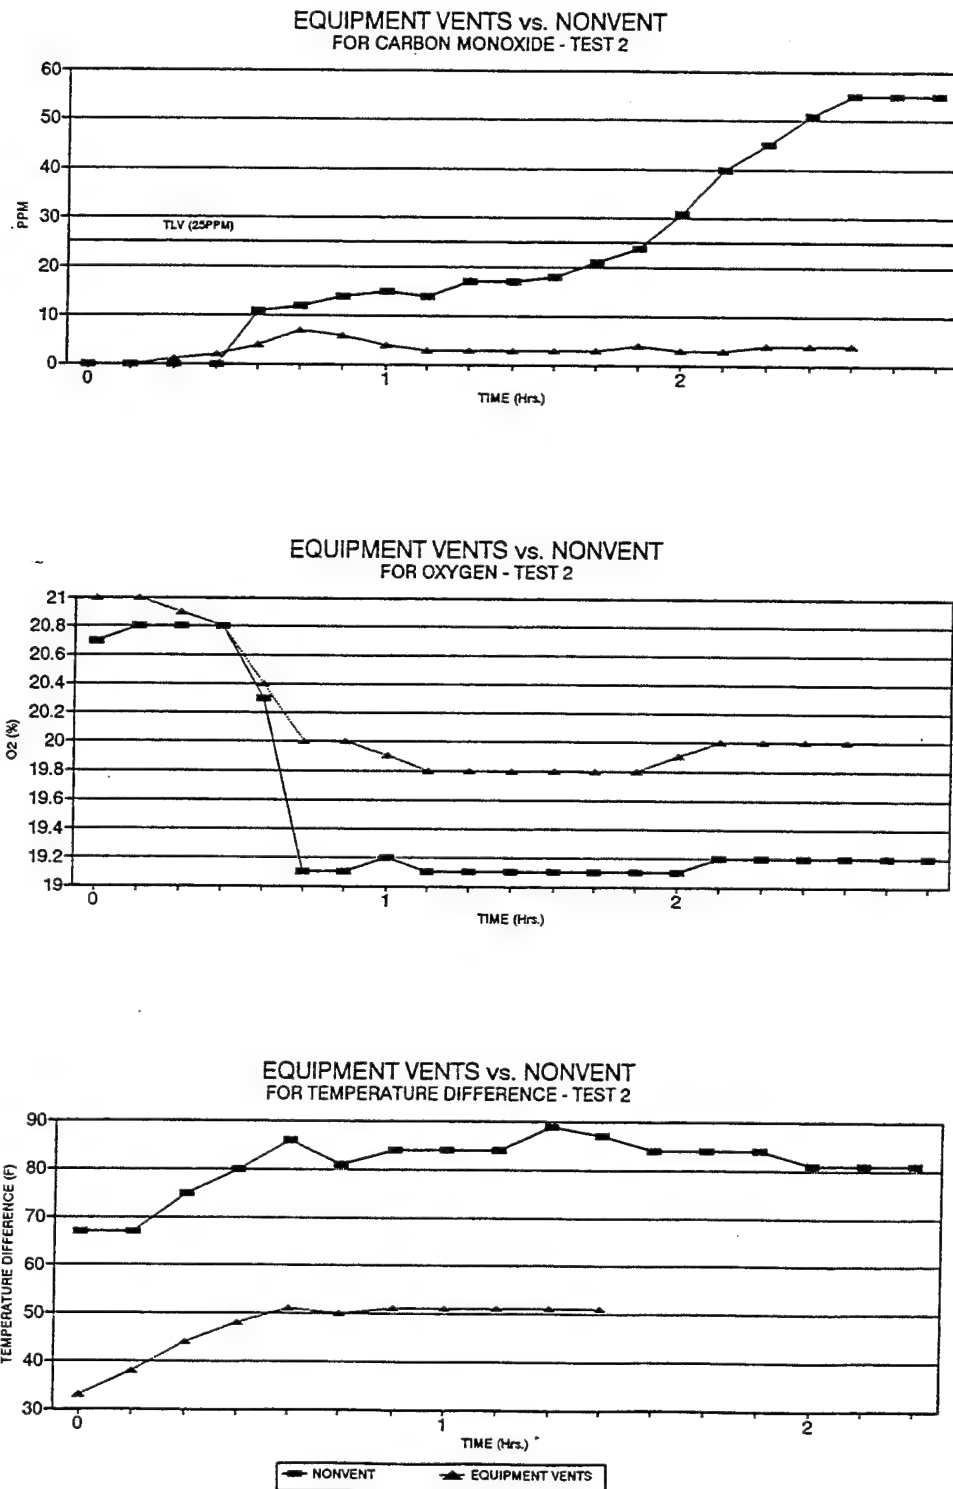
Figure 16. Gas concentrations and temperature difference within the Mobile Kitchen Trailer when using three M-2 burners at an ambient temperature of 45°F (test 2).

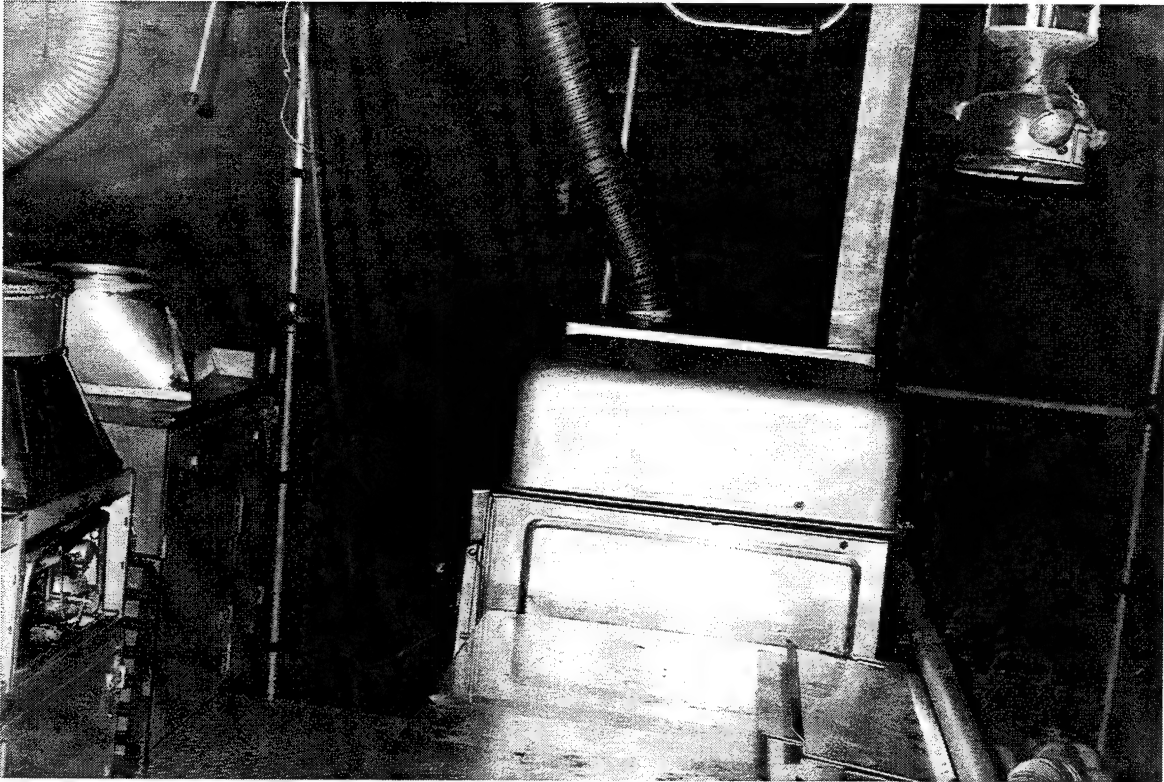
Figure 17. M-59 Range Cabinet with the second equipment vent installed.

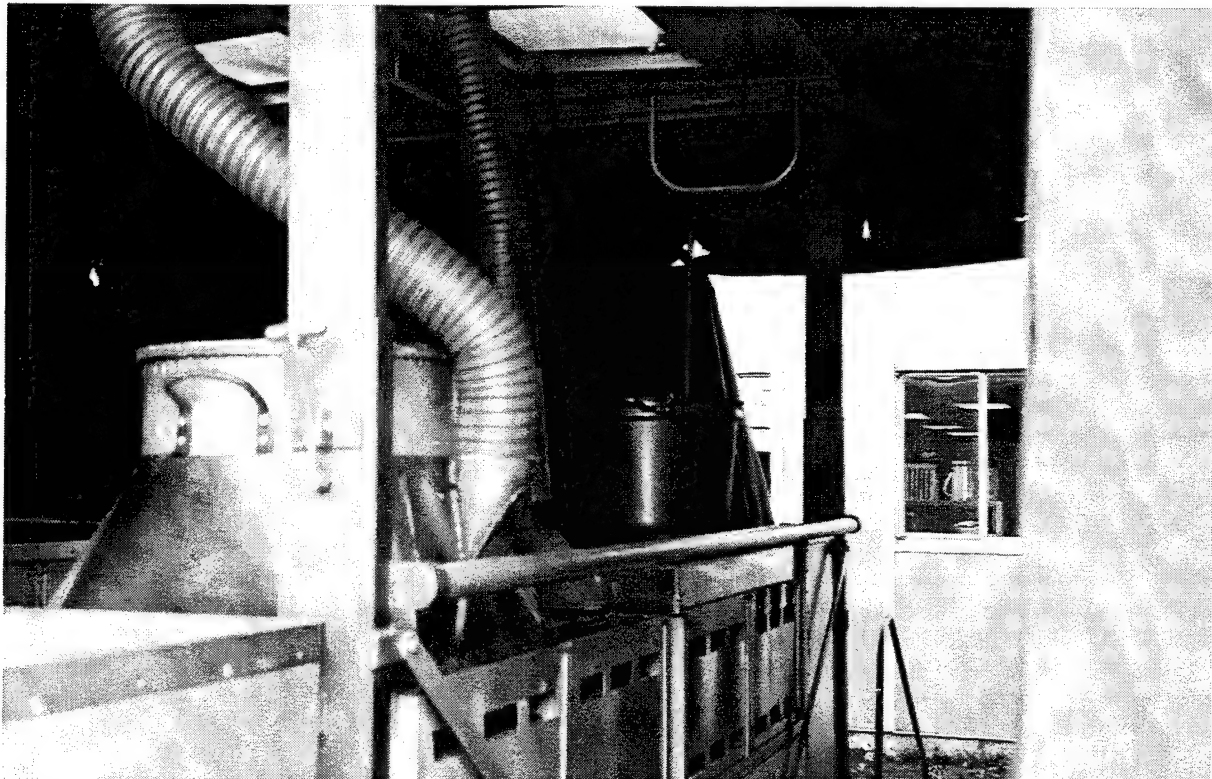
Figure 18. Cowl and stack used for the second set of equipment vents.

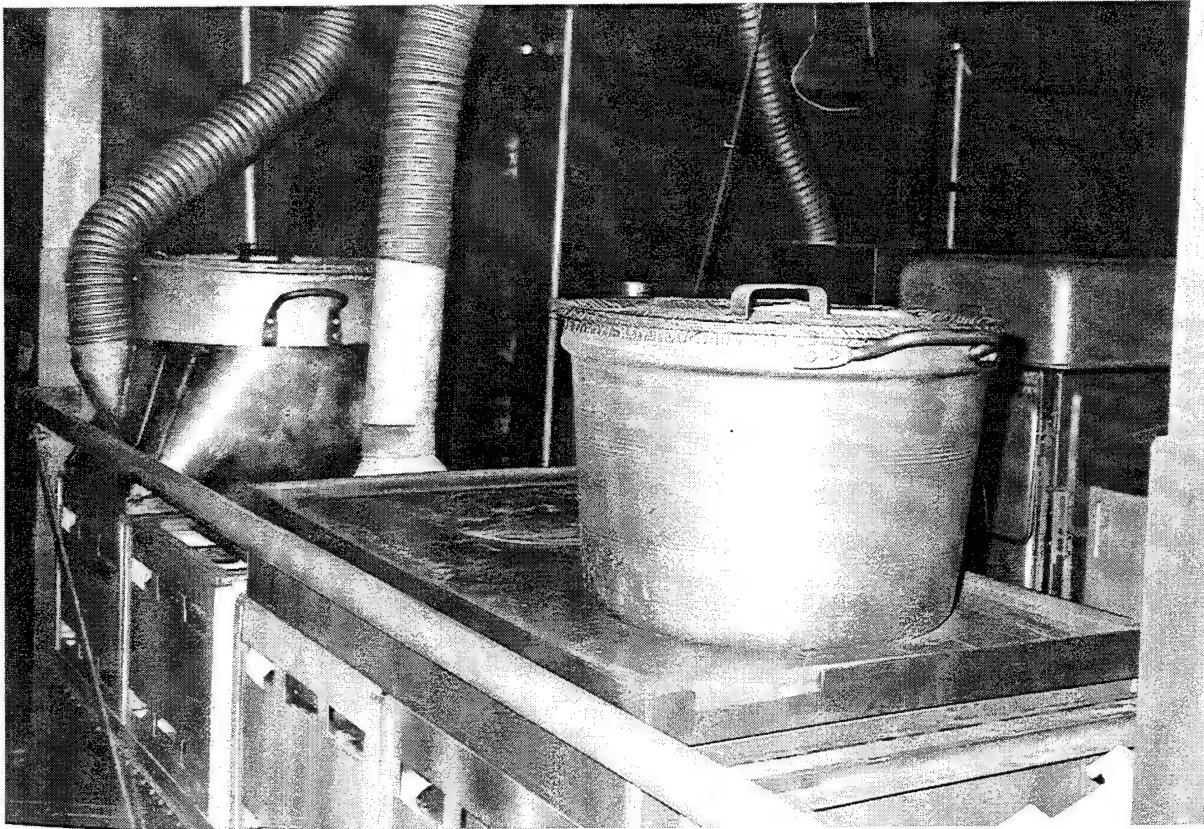
The grill, M-59 range cabinet and the griddle's position that were closest to the outer ends of the center aisle were the positions chosen for the improved vents. The improved vents were installed by positioning each equipment vent (the top cover for the M-59 range cabinet, the cowl and the griddle riser) below each chimney collar. The vents were positioned so that they did not interfere with cooking or serving. The lower ends of the flexible tubes were then cut to length and slid over the stack outlets for each equipment vent. Pictures of the configuration for the M-59 range cabinet and cowl can be shown in Figures 17 and 18, respectively. Another picture of the cowl and stack connecting to a substitute roof vent is shown in Figure 19.

Figure 19. Griddle and stack for the improved equipment vents.

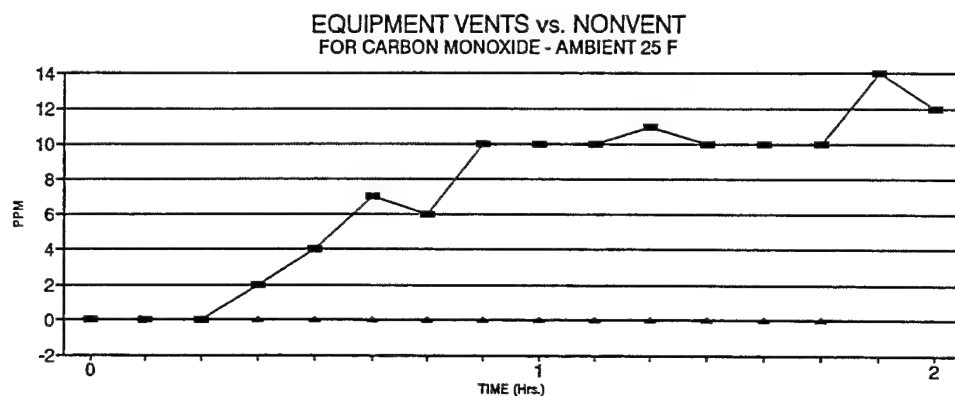
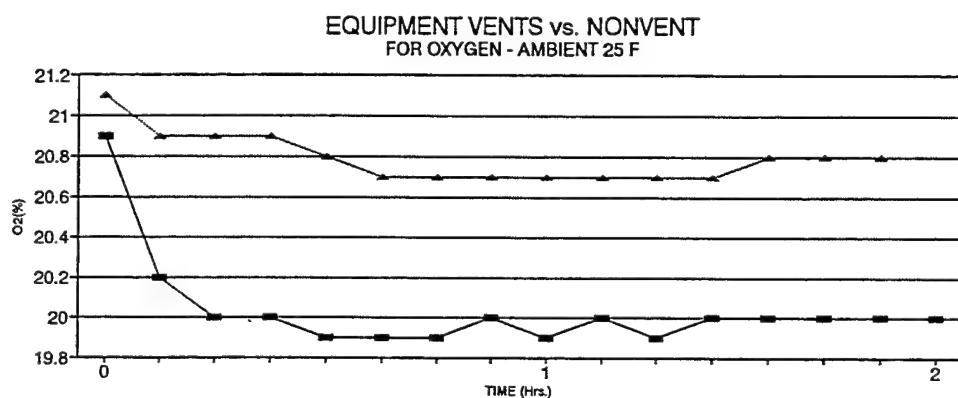
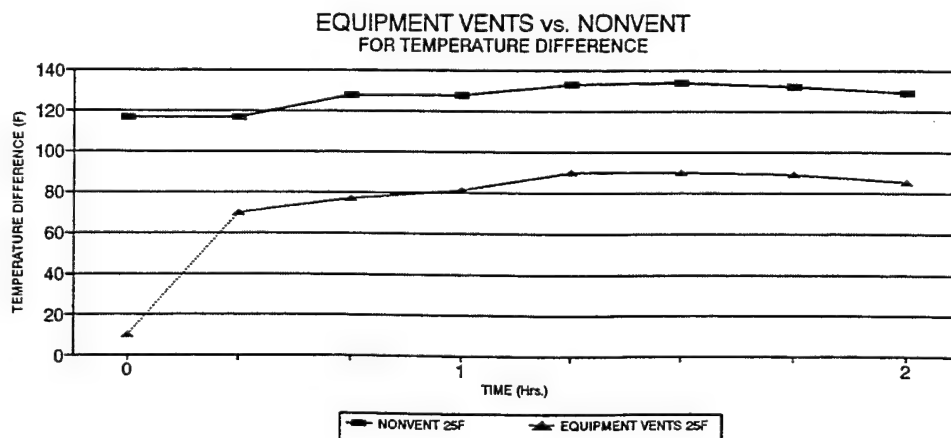
Figure 20. Gas concentrations and temperature difference within the Mobile Kitchen Trailer when three M-3 burners at an ambient temperature of 25°F.

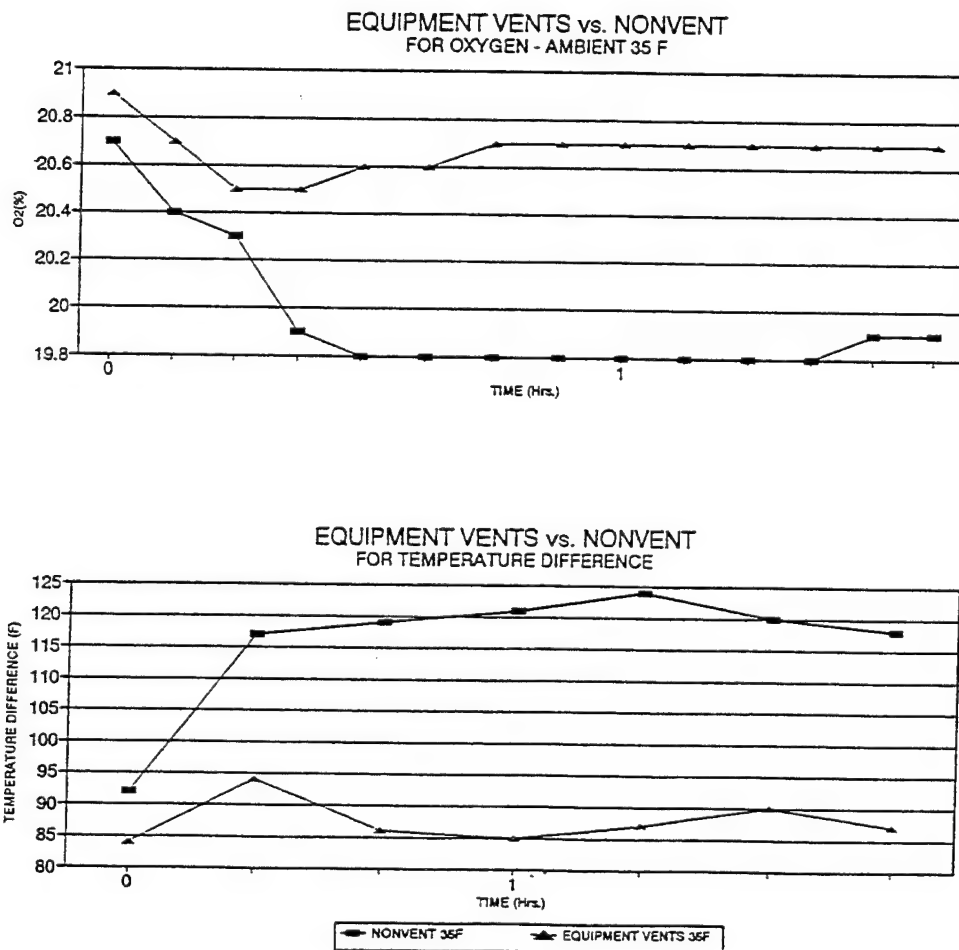
Figure 21. Gas concentrations and temperature difference within the Mobile Kitchen Trailer when using three M-3 burners at an ambient temperature of 35°F.

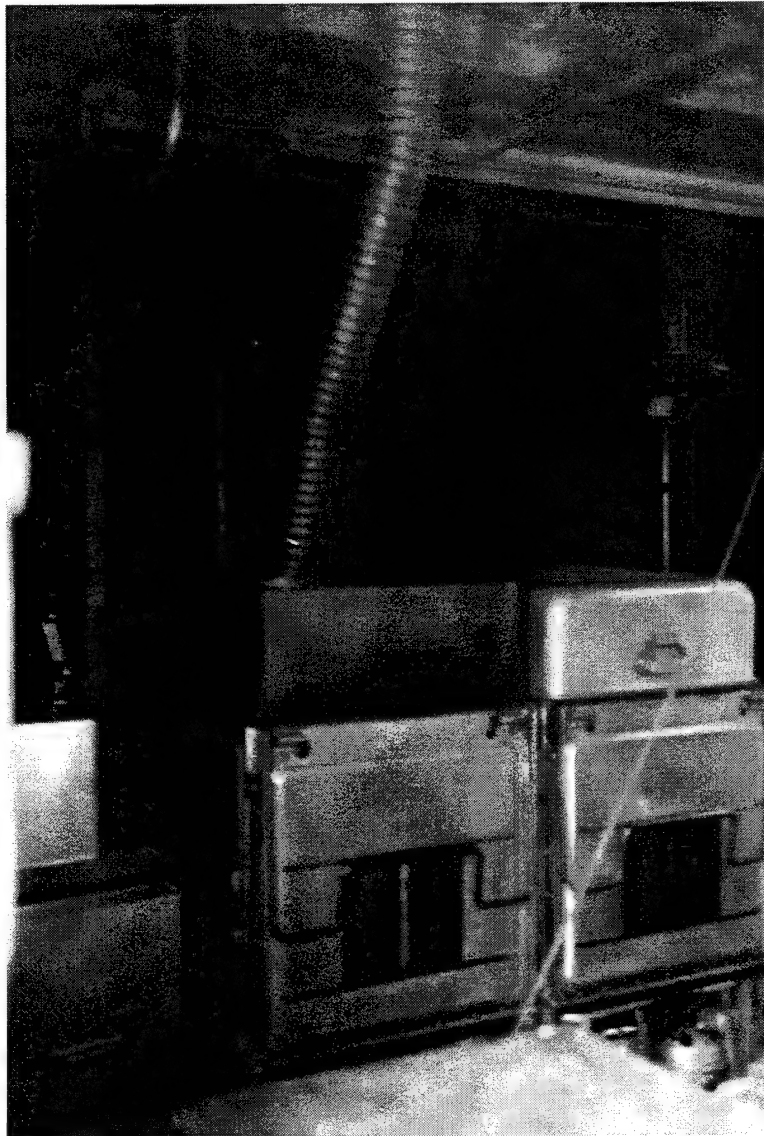
For the formaldehyde testing, a combination of the initial and improved equipment vents had to be used, because the testing took place in a different MKT. For the M-59 range cabinet, the initial equipment vent was used. The improved vents were used for the cowl, griddle riser and stacks. A picture of the M-59 range cabinet configuration is shown in Figure 23. The stacks were attached to the substitute roof vent covers built for the initial equipment vents.

Figure 22. M-59 range cabinet, with the equipment vent used for the formaldehyde testing.
